DEPARTMENT OF TRANSPORTATION

Contract #: 04-0120F4Cty: SF/ALA Rte: 80 PM: 13.2/13.9File #: 69.28**WELDING INSPECTION REPORT****Resident Engineer:**Siegenthaler, Peter**Address:** 333 Burma Road**City:** Oakland, CA 94607**Report No:** WIR-022431**Date Inspected:** 05-Apr-2011**Project Name:** SAS Superstructure**OSM Arrival Time:** 700**Prime Contractor:** American Bridge/Fluor Enterprises, a JV**OSM Departure Time:** 1900**Contractor:** Zhenhua Port Machinery Company, Ltd (ZPMC), Changxing Island **Location:** Shanghai, China**CWI Name:** Zhou Zhong Hai**CWI Present:** Yes No**Inspected CWI report:** Yes No N/A**Rod Oven in Use:** Yes No N/A**Electrode to specification:** Yes No N/A**Weld Procedures Followed:** Yes No N/A**Qualified Welders:** Yes No N/A**Verified Joint Fit-up:** Yes No N/A**Approved Drawings:** Yes No N/A**Approved WPS:** Yes No N/A**Delayed / Cancelled:** Yes No N/A**Bridge No:** 34-0006**Component:** OBG COMPONENT**Summary of Items Observed:**

WELDING INSPECTION REPORT

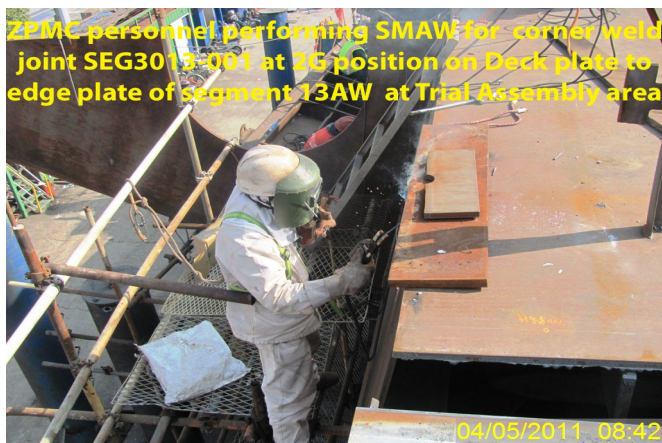
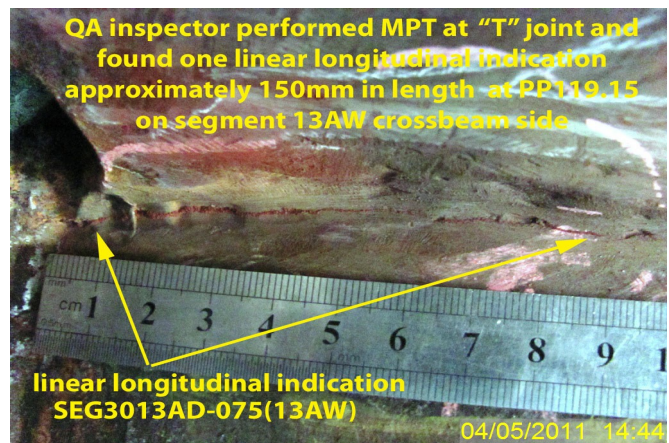
During visual inspection at Panel Point PP119.15 at crossbeam side of segment 13AW this QA inspector observed one linear longitudinal indication approximately 150mm in length. The weld joint is identified as SEG3013AD-075. After that this QA confirmed with magnetic particle testing. Then the QA inspector informed to ABF QA Mr. Wen Jian Bo and ZPMC QC Mr. Shen Jian Bao to make weld repair report and repair that mention weld joint. For more information please see the attached photo.
